Retrieval of Knotted and Stripped Guidewires Lost During Percutaneous Intervention on Kidney—A Case Series and Review of Literature

Objective: The complication associated with percutaneous interventions done on kidneys are usually easily identified and managed with defined protocols. These usually include bleeding, surrounding organ injury, or sepsis. Stripping or knotting of glide-wire during these procedures is rare and have no defined management guidelines. There is a paucity in the literature about the management of these complications. A case series is reported on the management of this rare complication.

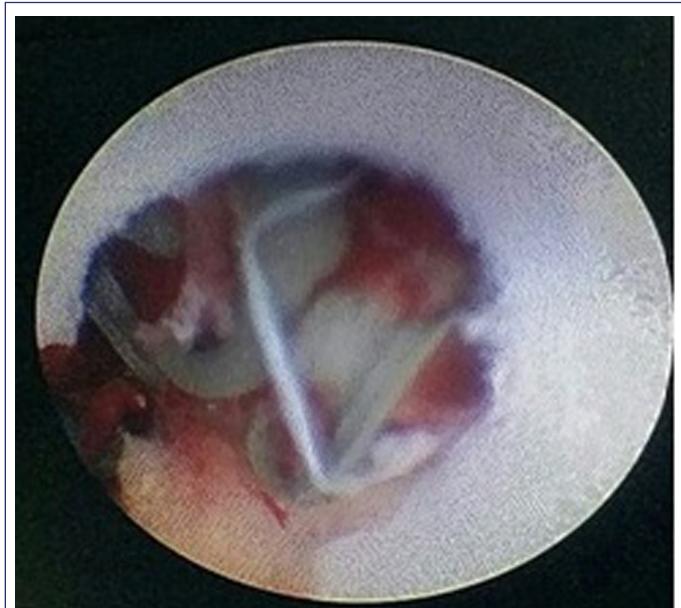
Figure 2. Endoscopic view of stripped loop.

Case 1: A 32-year-old male underwent mini-PCNL (mPCNL) for a partial staghorn calculus extending into the middle calyx. Under fluoroscopic guidance, a middle calyceal puncture was made with an 18G initial puncture needle and a 0.032 inch hydrophilic guidewire was passed through. The guidewire could not be satisfactorily parked in the pelvicalyceal system (PCS) due to an impacted middle calyceal calculus and was getting coiled abnormally around the stone. After repeated failed attempts to pass the guidewire into the collecting system, it was removed with the puncture needle in place. During removal, the guidewire got stripped and the jacket was lost in the renal parenchyma. Another calyceal puncture was made and tract dilated to clear the stone. There was no endoscopic trace of the stripped guidewire in the PCS, though it was visible on fluoroscopy. The procedure was carried under spinal anesthesia and a lot of time was spent on searching for the stripped guidewire, so a DJ stent and nephrostomy tube were placed, and the procedure was concluded. A postoperative x-ray showed the stripped guidewire coiled in the renal area. A non-contrast computed tomography (CT) scan revealed the stripped guidewire in the renal parenchyma near the middle calyx. After 48 hours patient was again taken to operating room to remove the residual guidewire. Under fluoroscopic guidance the puncture was made directly on the stripped loop (Figure 1). A new guidewire was placed into the PCS under fluoroscopic guidance. Tract was dilated to 12 Fr and 8.5 Fr ureteroscope was passed through the sheath. The stripped wire was identified and removed intact (Figure 2).

courage, and intellect of the surgeon. Rare complications of stripping and fragmentation of guidewires were encountered during percutaneous procedures done on the kidney. In Case 1, stripping of the guidewire was identified intraoperatively while examining the remnant guidewire. The stripped loop could not be retrieved immediately because a lot of time was already spent searching the stripped fragment, and the spinal anesthetic effect was weaning off. When an abnormally coiled guidewire is pulled forcibly through a puncture needle, the jacket may get stripped from the nitinol core by the edge

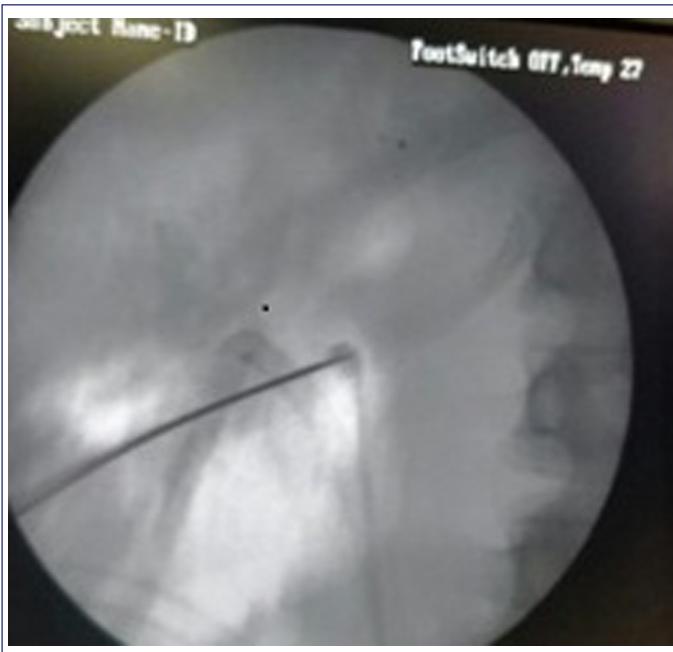
Figure 1. A puncture was made directly on the stripped loop.

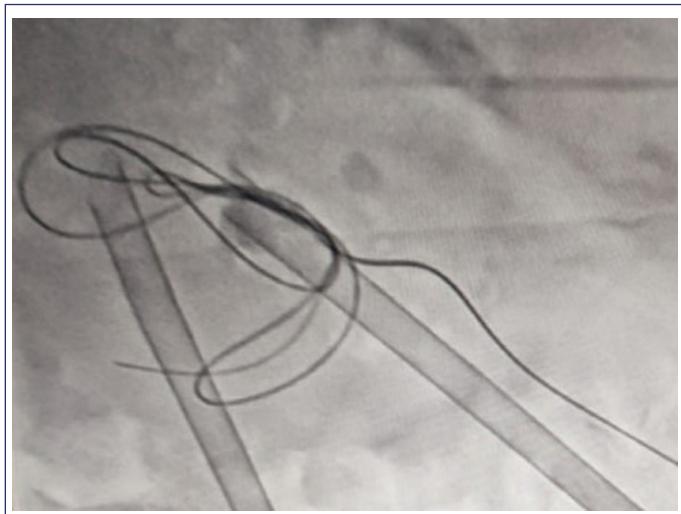
Figure 3. Knotted guidewire is seen on fluoroscopy with the Amplatz sheath in the middle and lower calyx.

Case 2: A 52-year-old male with staghorn calculus was planned for mPCNL. An inferior calyceal puncture was made, and upon parking the guidewire, knotting occurred, and guide wire could not be removed

after repeated failed attempts. The needle was removed, and guidewire left in place. A middle calyceal puncture was made and tract dilated to clear the stone from the middle calyx and pelvis. There was no endoscopic trace of the knotted guidewire. Another lower calyceal tract was established to remove the residual stone and search for the knotted guidewire. Again, there was no trace of the guidewire in PCS (Figure 3). To remove the knotted guidewire, the tract was dilated on the wire itself up to the knot, and 16 Fr Amplatz sheath was placed (Figure 4). Nephroscope was introduced and the knot divided with thulium fiber laser (TFL). All fragments were removed, and clearance confirmed on fluoroscopy.

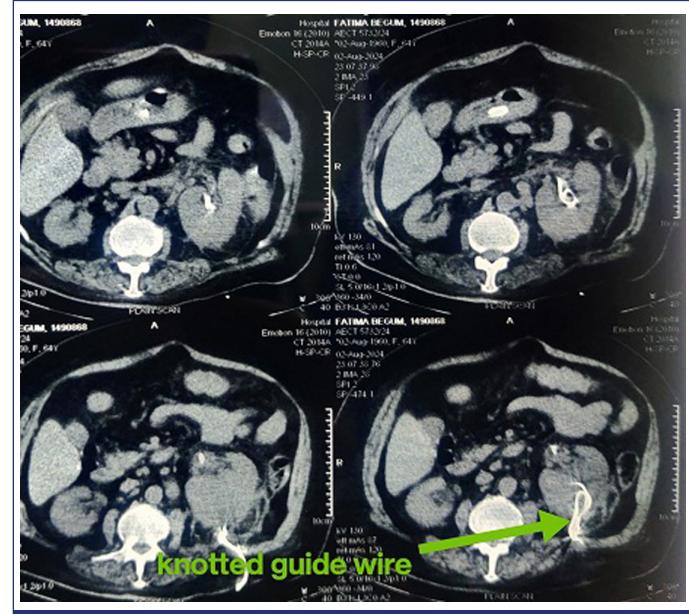
Figure 5. CT scan showing knotted guidewire partly inside renal parenchyma.

perinephric collection was planned. During malecot tube deployment, the guidewire could not be removed. The tube was taken out expecting the guidewire to accompany it, but the guidewire was knotted. Repeated attempts to remove the knotted guidewire resulted in breakage, leaving small stump outside the skin. A fresh malecot catheter was placed in the perinephric collection, and the fragmented guidewire was left in place and secured to skin to avoid internal migration. The patient improved, and a repeat CT showed no residual collection and the guidewire knotted outside the kidney in retroperitoneum (Figure 5). Three weeks later, the patient was planned for removal of the fragmented guidewire. Due to the small stump of the knotted guidewire left outside the skin, tract dilatation directly on the fragmented wire was not possible. Under fluoroscopic guidance, the knot was precisely punctured with an 18G initial puncture needle, and a hydrophilic guidewire was passed close to the knot. Tract was dilated up to 16 Fr, and an Amplatz sheath was placed (Figure 6). Nephroscope was introduced and knot was fragmented with Holmium:YAG laser. All fragments were removed, and the procedure was uneventful (Figure 7).

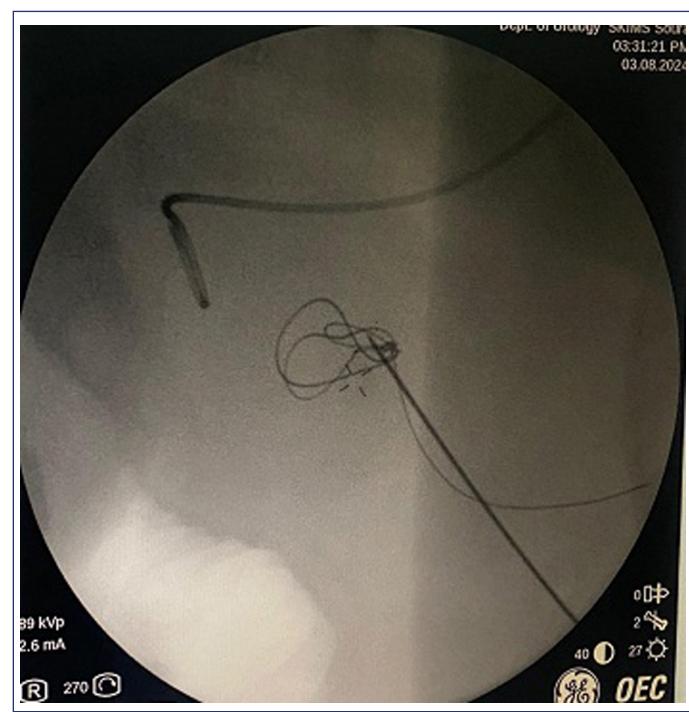
Figure 6. The knot was directly punctured under fluoroscopic guidance.

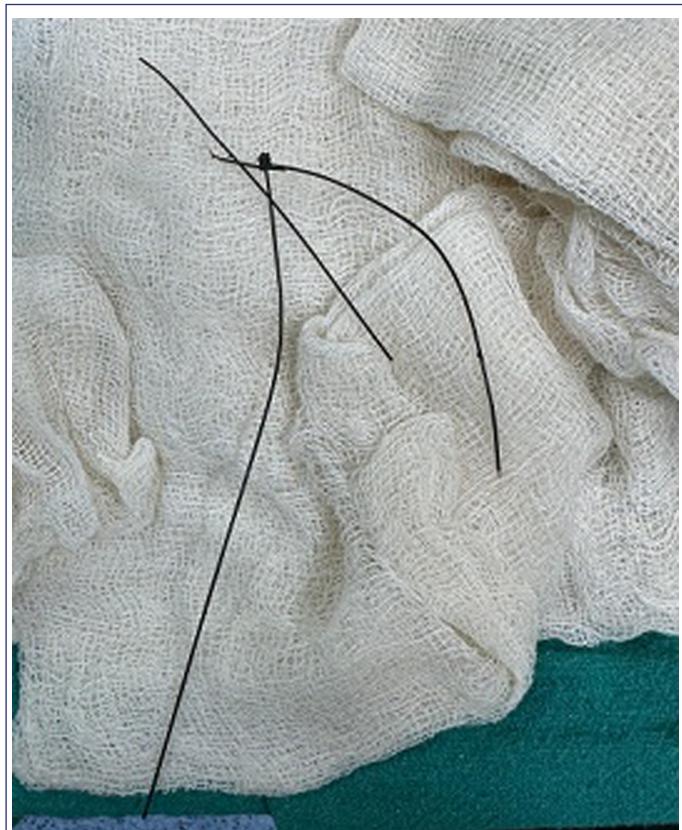
Figure 7. Knotted guide retrieved with a tight knot.

The Terumo hydrophilic guidewire used consists of a super-elastic nitinol alloy core for optimal performance and kink resistance. The tungsten-infused polyurethane jacket provides superior tip and wire radiopacity. Overuse of the same guidewire, deformed guidewires, excessive use of force to park the guidewire, and compact PCS with tightly packed stones are some main risk factors for knotting.⁹ Fragmentation may be the result of the direct impact of laser energy on wires in endourologic procedures. Fragmented guidewires lost in PCS act as a nidus for stone formation, non-resolving urinary tract infections, and chronic draining sinuses. Franklin L et al reported a recurrent stone formed on a fragmented guidewire lost in PCS from a previous intervention.¹⁰ Fragmentation and knotting of guidewires have been reported in endovascular interventions, and the literature about the same in urology practice is sparse. Knotted guidewires can be removed by open technique or percutaneously through small tracts. When sufficient length is available, the tract may be dilated up to the knot, and a laser used to unravel the knotted guidewire. When sufficient wire is not available for tract dilation, the knot can be safely targeted under fluoroscopic guidance, and the tract established to divide the knot.
